FATAL ACCIDENTS DUE TO FLYROCK AND LACK OF BLAST AREA SECURITY AND WORKING PRACTICES IN MINING

National Institute for Occupational Safety and Health
Pittsburgh, Pennsylvania, USA

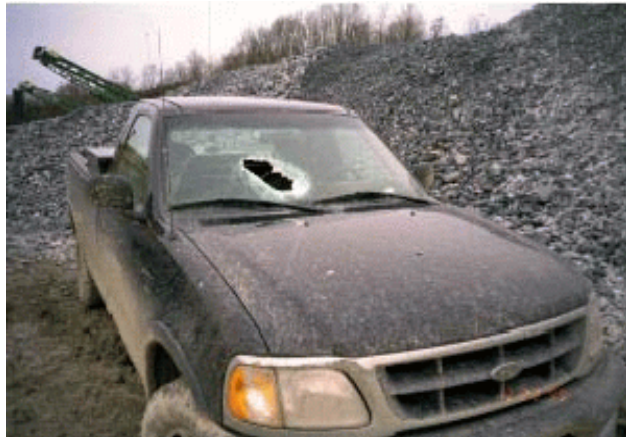
1. Fatal injury due to flyrock at a limestone mine in Pennsylvania (Case Study No.6)
Source: MSHA, 1999b

6. Nonmetal Mine, Lancaster County, PA: On December 21, 1999, a 32-year-old equipment operator was in a pickup truck while guarding an access road leading to the blast site [MSHA, 1999b]. The pickup truck was about 800 ft from the blast site. Flyrock entered the cab through the windshield and fatally struck the victim (Figure 1). The victim had seven years mining experience as an equipment operator at this mine.

The mine normally operated two 8-10 hour shifts a day, five days a week, and had 22 employees. The mining company used a drilling contractor to drill the holes, and a blasting contractor for loading and blasting. The highwall face was about 50 ft high and the depth of holes ranged between 49 and 54 ft. The blast round consisted of 22 holes drilled on a 16- by 16-ft pattern. Approximately 9,595 lb of explosives were used in this round and the length of stemming varied from 9 to 36 ft. The weight of explosive used in each blasthole was not recorded. Some of the holes were slanted up to 25° toward the highwall to compensate for irregularities in the highwall face. The investigation report indicated that at least one of the blastholes blew-out causing a massive amount of flyrock. This incident emphasizes several factors, such as excessive powder loading, voids, discontinuities, break in the rock strata, and blasthole inaccuracy.

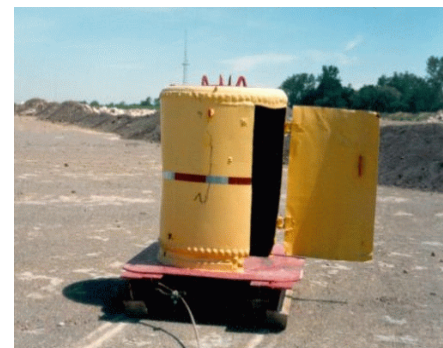
At a surface mine a blasting shelter (Figure 2) was readily available for use. No one was allowed in the blast area after blastholes were loaded and lead-in line connected. The blasting shelter was available for the blaster to stay inside the blast area during any scheduled blasting. In general, access to the blast area was controlled by signs, barricades, and ground supervision. The blaster removed all unused explosives, communicated with the guards, and visually inspected the bench top prior to firing the shot. Radio communication was used by personnel involved in these activities.

2. Blasting shelter
